Process Analysis of Toppling Failure on Anti-dip Rock Slopes Under Seismic Load in Southwest China

Abstract

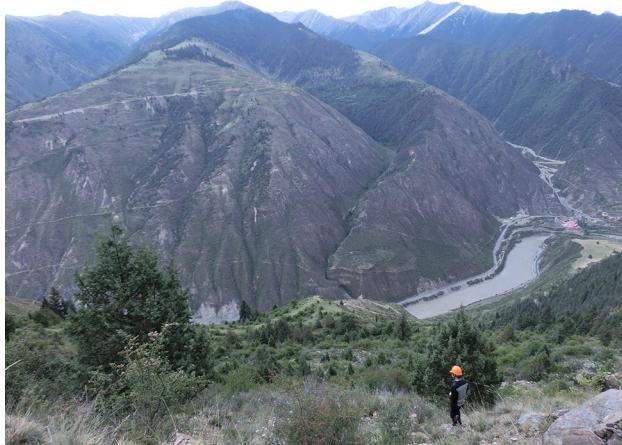
Fig. 4 High canyon landscape in the study area

1. Since the beginning of the Quaternary, the crust has uplifted rapidly, and the rivers have incised considerably. This area was deeply cut by the Yalong River, and steep slopes were formed on both sides of the valley (Fig. 4). All three toppling slopes were developed in areas with a steep slope angle and rock strata that dip into the slope at a high angle (Fig. 5); therefore, the slope and dip angles are two of the important impact factors of the slope stability in the area.

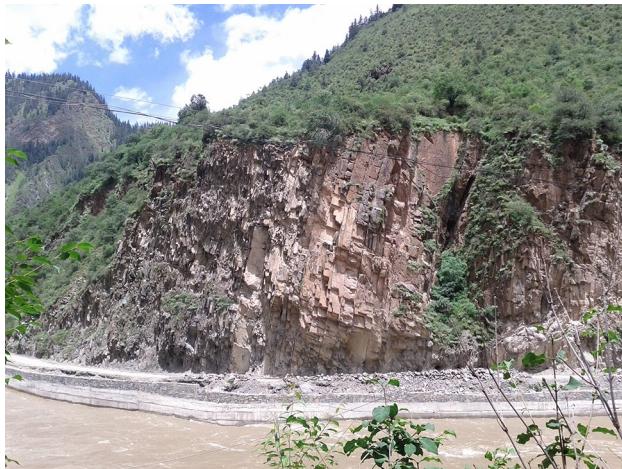
Fig. 5 Sub-vertical strata in the lower part of the slope

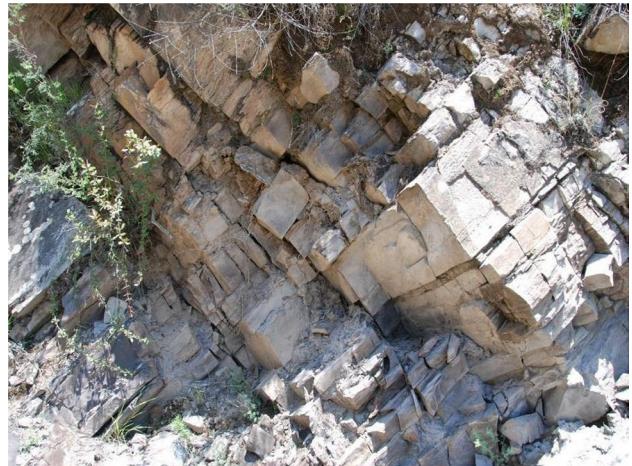
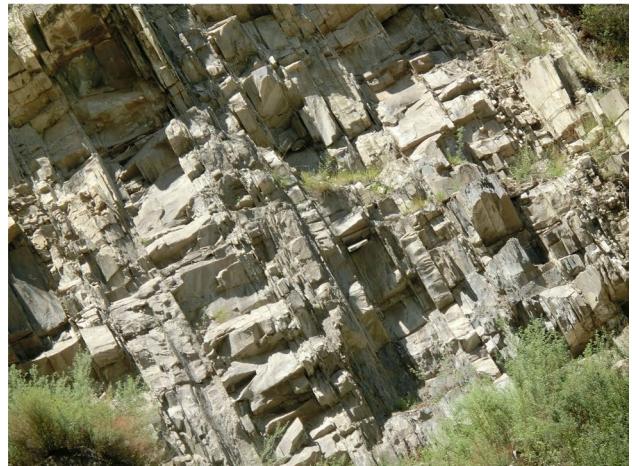
Fig. 6 Well-developed cross joints in sandstone exposed in the Yalong River upstream basin

(a) Cross joints in sandstone exposed in the Jiaxi toppling slope

(b) Cross joints in sandstone exposed in the Mari toppling slope

Based on the toppling slope characteristics, the structure of the sandstone slopes was mainly controlled by the rock layers and a set of well-developed cross joints, nearly perpendicular to the rock layers and dipping away from the slope, cutting the layered rock mass into short columns (Fig. 6).

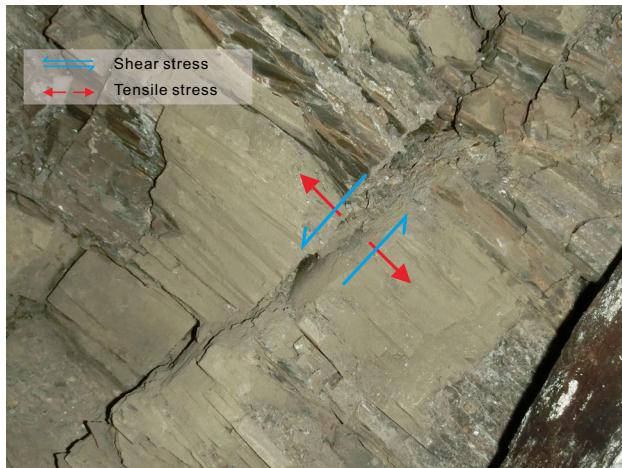
Fig. 7 Deformation and failure characteristics inside the toppling slopes

(a) Bending zone of rock strata

(b) Tensile cracks in the strata

(c) Tensile-shear plane cutting the strata

3. Based on the results of adit investigations, the deformation inside the bank slope showed that the rock columns bent towards the free surface under the effect of the seismic waves and gravity field. A step-like fracture plane, dipping away from the slope, was formed by the propagation and coalescence of the cross joints in the strata at the maximum bending zone of the rock columns, and a certain shear displacement existed between the hanging wall and footwall along the fracture plane (Fig. 7a). Tensile cracks formed in the strata due to the shear dislocation between rock layers during the toppling deformation process (Fig. 7b), and tensile-shear cracks gradually formed with increasing deformation (Fig. 7c). The observations above suggest that the deformation mechanism was toppling deformation.
